**A HUMAN FACTORS ANALYSIS OF
HIGHWAY-RAILWAY GRADE CROSSING
ACCIDENTS IN CANADA**

Prepared for
Transportation Development Centre
Transport Canada

by
Cognitive Ergonomics Research Laboratory
Department of Psychology, University of Calgary

September 2002

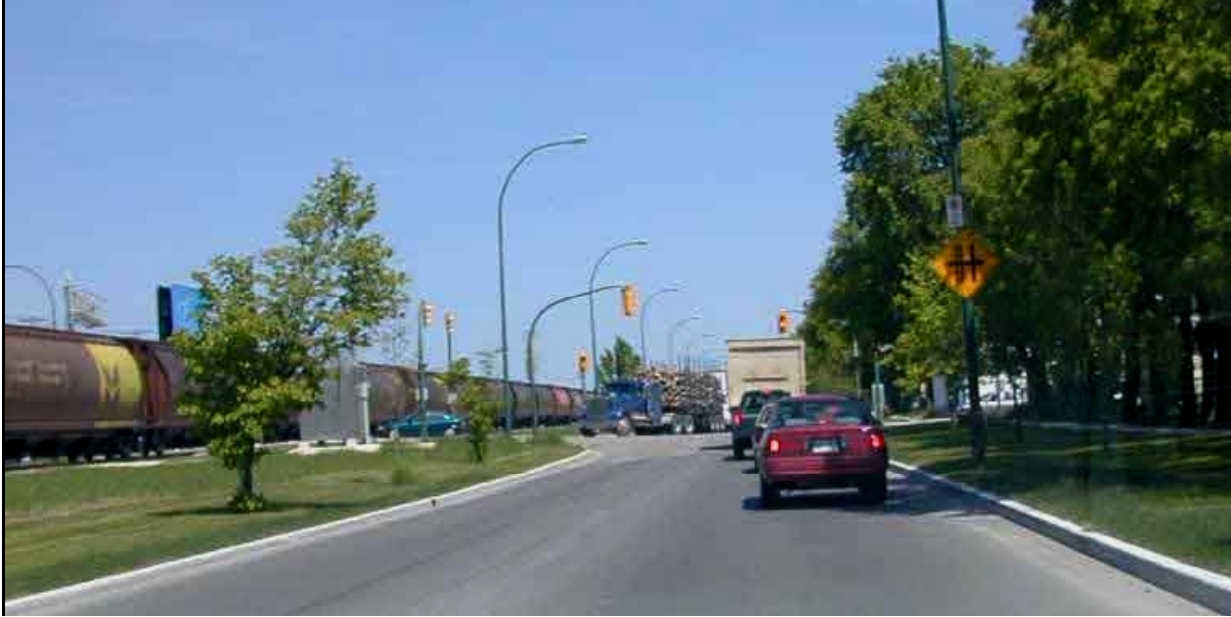
Figure 6.16 An intersection prior to a perpendicular crossing in an industrial area of Winnipeg. The AWS is partially obscured by tree branches and shadows on the right. The intersection ahead is controlled by lights (yellow). Notice the logging truck attempting to turn right in the intersection. The driver of the truck is blocking traffic in the intersection until the train has passed. The activity in the intersection demands the attention of the driver. The highway-railway grade crossing may receive less attention as a result.

Similarly, where a road travels parallel to a train track and then crosses it perpendicularly is also a known problem (Åberg, 1988; Wigglesworth, 1979). RODS, in combination with other data sources such as police and hospital reports, or the addition of more in-depth investigations may fill in these gaps in data and understanding. The qualitative analyses (Section 7) add somewhat to this accident configuration. Figure 6.16 illustrates the potential difficulties encountered at perpendicular crossings.
